ENVIRONMENTAL ASSESSMENT FRP GADSDEN COUNTY SOLAR

Gadsden County, Florida

Document Number 22JAX0125

Report Date: September 2022

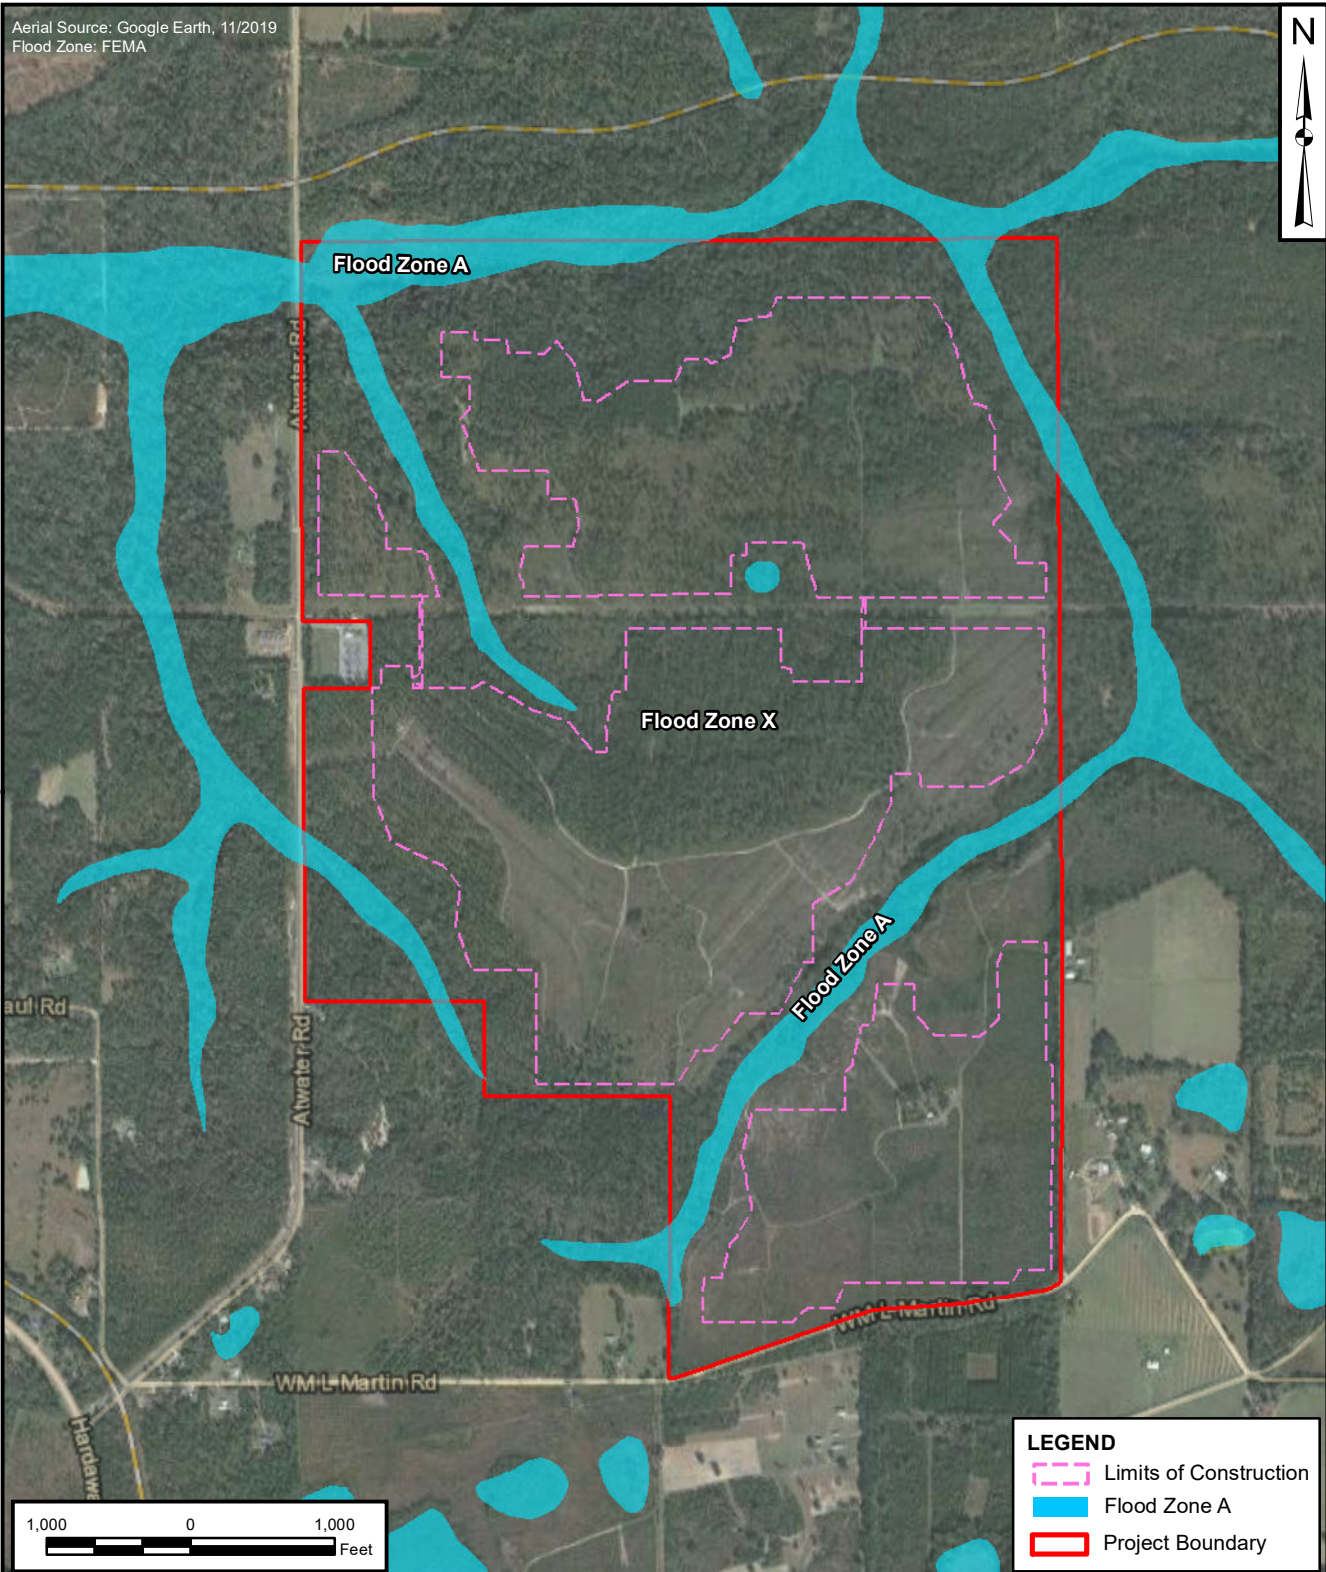
LEGEND	
	Limits of Construction
	Flood Zone A
	Project Boundary

According to FEMA FIRMs Panel #12039C0075C (effective 02/04/2009), the Project Boundary is predominately located in Zone X, indicating Area of Minimal Flood Hazard (Figure 4). These areas are outside of the SFHA and are usually depicted on FIRMs as above the 500-year flood level, defined as a 0.2% annual chance of flood. The Zone A areas depicted in Figure 4 are wetland

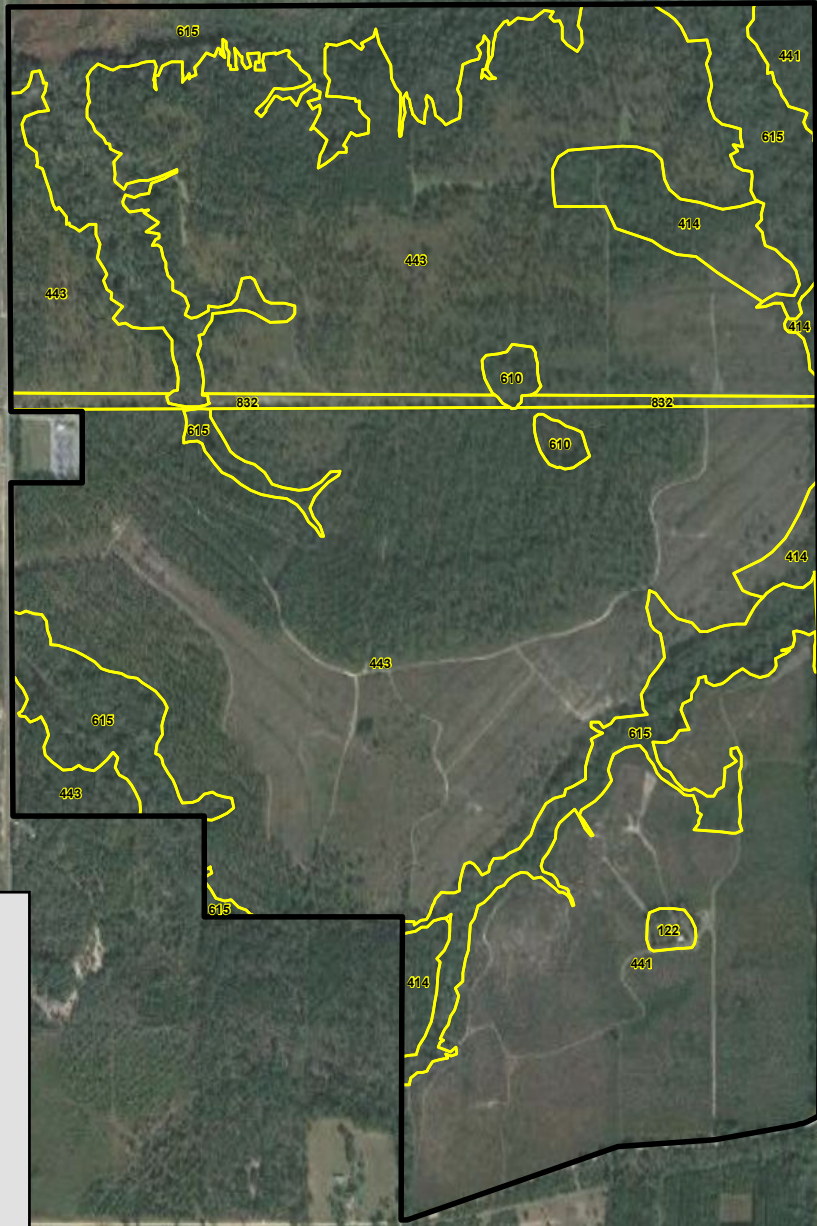
- 122 - Mobile Home Units
1.7 Acres
- 414 - Pine-Mesic Oak
25.1 Acres
- 441 - Coniferous Plantations
145.7 Acres
- 443 - Forest Regeneration Areas
482.7 Acres
- 610 - Wetland Hardwood Forests
4.5 Acres
- 615 - Stream and Lake Swamps
121.9 Acre
- 832 - Electrical Power Transmission
Lines: 9.5 Acres

Pine-Mesic Oak (FLUCFCS 414): On moister areas of the property, slash pine and loblolly pine grow in strong association with a wide variety of mesic oaks and other hardwood species. The dominant canopy observed includes laurel oak (*Quercus laurifolia*), water oak (*Quercus nigra*), southern magnolia (*Magnolia grandiflora*), and American holly (*Ilex opaca*). Gallberry (*Ilex glabra*) and wax myrtle (*Myrica cerifera*) were among the common understory species and the groundcover consisted of chalky bluestem (*Andropogon virginicus*). This cover type exists in areas abutting the on-site stream and lake wetlands and encompasses approximately 65 acres.

Coniferous Plantations (441) and Forest Regeneration Areas (443): The Project Boundary is predominantly covered by this land-use type and encompassed approximately 144 acres of Coniferous Plantation (441) and 482 acres of forest regeneration areas (443). According to historic aerial photographs, the planting and harvesting activities have been observed since at least 1947. In 2020, most of the coniferous plantation areas were harvested and not replanted. The FLUCFCS Map in Appendix A depicts the harvested (443) and unharvested (441) portions of the Project Boundary observed during the last site reconnaissance in August 2020. The remaining coniferous plantation is located in the southeastern area of the Project Boundary and was harvested and replanted with loblolly pine in 2018. Within the young Coniferous Plantation, the understory was dominated by red oak saplings (*Quercus falcata*), sweet bay magnolia saplings (*Magnolia virginiana*), common persimmon (*Diospyros virginiana*), American beautyberry (*Callicarpa americana*), blackberry, dog fennel, shiny blueberry (*Vaccinium myrsinites*), chalky bluestem, bracken fern, St. Johnswort (*Hypericum* spp.), and fetterbush.

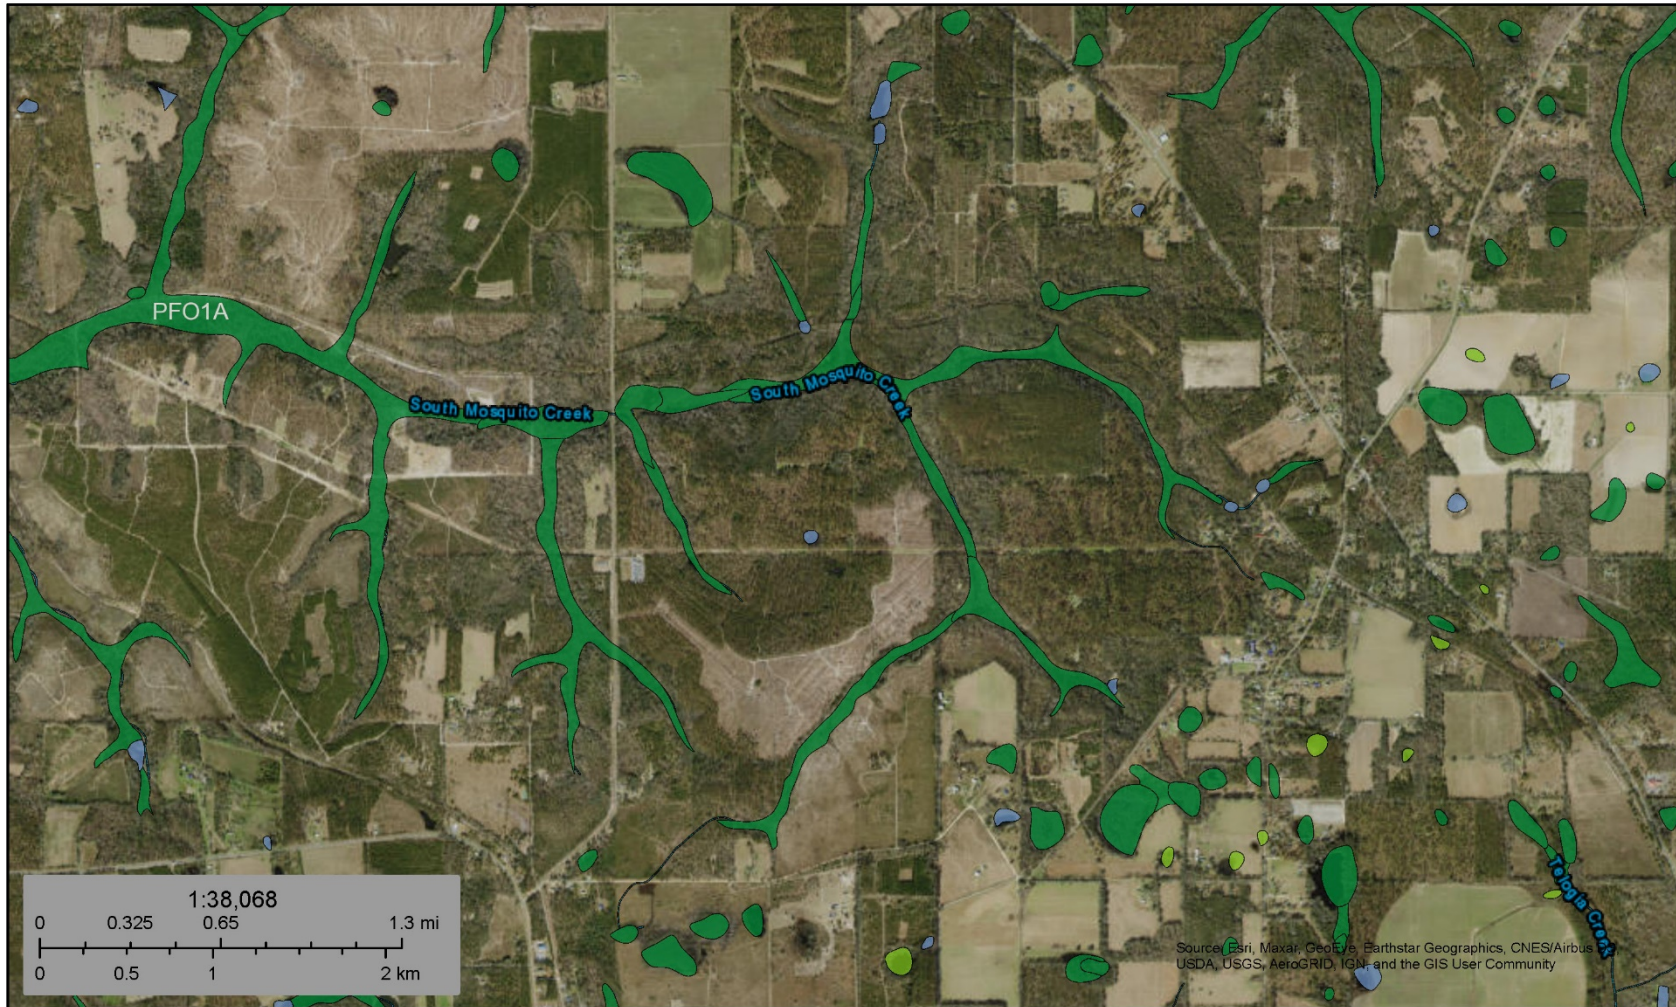
USFWS NATIONAL WETLANDS INVENTORY

This map is for general reference only. The US Fish and Wildlife Service is not responsible for the accuracy or currentness of the base data shown on this map. All wetlands related data should be used in accordance with the layer metadata found on the Wetlands Mapper web site.

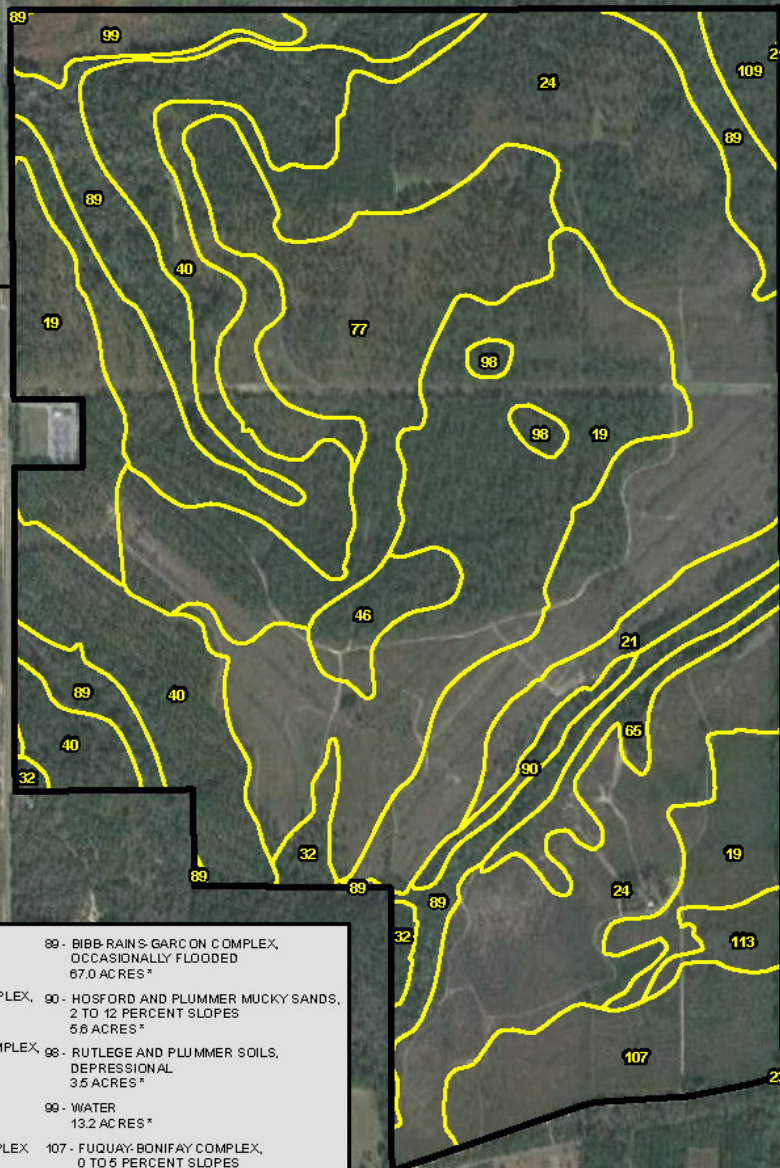
19 - DOTHAN-FUQUAY C COMPLEX, 2 TO 5 PERCENT SLOPES 157.2 ACRES	89 - BIBB-RAINS-GARCON COMPLEX, OCCASIONALLY FLOODED 67.0 ACRES *
21 - DOTHAN-FUQUAY-COWARTS COMPLEX, 8 TO 15 PERCENT SLOPES 16.2 ACRES	90 - HOSFORD AND PLUMMER MUCKY SANDS, 2 TO 12 PERCENT SLOPES 5.6 ACRES *
23 - FUQUAY-LUCY-ORANGEBURG COMPLEX, 0 TO 5 PERCENT SLOPES 0.1 ACRES	98 - RUTLEGE AND PLUMMER SOILS, DEPRESSIONAL 3.5 ACRES *
24 - FUQUAY-BONIFAY COMPLEX, 5 TO 15 PERCENT SLOPES 236.1 ACRES	99 - WATER 13.2 ACRES *
32 - LEEFIELD-BONIFAY-DOTHAN C.COMPLEX, 0 TO 5 PERCENT SLOPES 8.4 ACRES	107 - FUQUAY-BONIFAY COMPLEX, 0 TO 5 PERCENT SLOPES 36.7 ACRES
40 - COWARTS-DOTHAN-FUQUAY COMPLEX, 15 TO 80 PERCENT SLOPES 115.3 ACRES	109 - DOTHAN-COWARTS-FUQUAY C.COMPLEX, 15 TO 80 PERCENT SLOPES 8.4 ACRES
46 - ORANGEBURG LOAMY SAND, 2 TO 5 PERCENT SLOPES 11.1 ACRES	113 - LEEFIELD FINE SAND, 0 TO 5 PERCENT SLOPES 7.4 ACRES
65 - UD ORTHENTS, RECLAIMED 12.4 ACRES	* = HYDRIC SOIL

77 - BONIFAY-FUQUAY COMPLEX, 0 TO 5 PERCENT SLOPES 89.0 ACRES *
